## LOAD-BEARING CAPACITY ANALYSIS OF BUILDING PARTITIONS OF THE COLD STORAGE CHAMBERS

**Chmielewski R., Kruszka L., Muzolf P.**

*Military University of Technology, Warsaw, Poland*

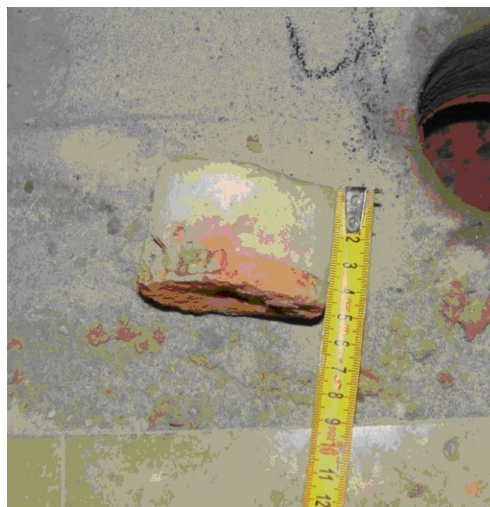
thickness. An example of such a misinterpretation is the assumption of the designer and the later use of a 9 cm thick concrete slab (a top layer) in the Ackerman ceiling in the building built in the 1940s [1]. In literature, this thickness is assumed to be 3 cm or 4 cm. If it is necessary to increase the usable height of the cross-section, an additional perforated brick layer is being used on the hollow brick layer. The designer took that wrong dimension on the basis of the result of one inspection hole, which was drilled near the reinforced concrete stairs. As a result of the erroneous determination of the ceiling load-bearing capacity, together with the builder fault of the contractor, the ceiling structure was damaged. This also implied the need to verify the design and implemented solutions. Five additional testbore-holes of the Ackerman block ceiling layers were made, in which the thickness of the concrete overlayer was found to be less than 4 cm – Fig. 1.

Fig. 1. Measurement of the thickness of the concrete slab – the overlayer of the Ackerman block ceiling

Another frequent error occurring during the verification process of the load-bearing capacity of existing structures is the failure of taking into account the actual thickness, and thus the loads of the non-structural layers. In the Ackerman ceiling case described above, one of the errors was the lack of removal of the screed layer, which the designer mistakenly treated as a structural layer. To make matters worse, an additional concrete floor of 6.5 cm was made, which resulted in an additional total ceiling load with a characteristic value of 1.63 kN/m<sup>2</sup> [1]. Another case, which the authors met in their expert practice, concerned the failure to take into account the weight of the layers on the ceiling. In this case, the designer did not take into account 10 cm of insulating board made of wood chips and 6 cm of extra concrete layer, which gave the total characteristic load of 1.94 kN/m<sup>2</sup> [1]. In both described cases, it was necessary to dismantle non-structural layers, including new finishing layers.

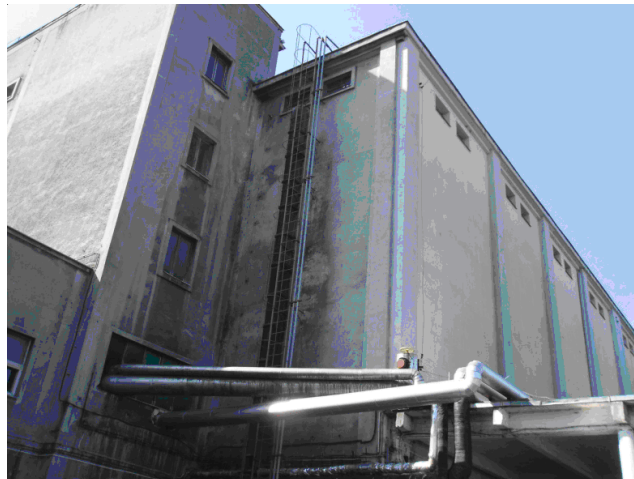
Fig. 2. General view of the cold store in Włocławek

**1.2. Cold storage in Włocławek (Poland).** Similarly to the building described above, the Włocławek cold storey was erected in the 1950s – Fig. 2. It is a fine-storey reinforced concrete building with a frame structure. The roof of the building is a slab-beam structure. Its columns with a cross-section of 0.2×0.2 m (partially 0.25×0.25 m) are articulated on the heads of the columns of the third floor. Cross-sections of reinforced concrete columns of the supporting structure vary on individual floors:

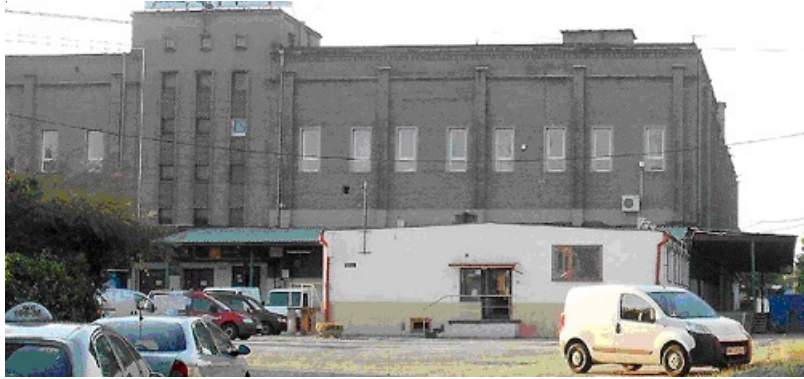
the inter-story slabs and columns at the ground floor level – Fig. 3. In the first place, the loads and self-weight acting on the ceiling were calculated. The actual thicknesses of the ceilings and finishing layers was taken into account, which were verified in the performed in-situ inspection holes. The determined design value of the pressure applied on the floor layers was 8.29 kN/m<sup>2</sup>. On the basis of abovementioned inspection holes, it was found that the spacing of the steel beams was 1.34 m, while the maximum span was  $l_0 = 4.8$  m – Fig. 4. The supporting elements of the ceiling were I240 rolled I-beams.

Fig. 3. General view of the cold store in Warsaw

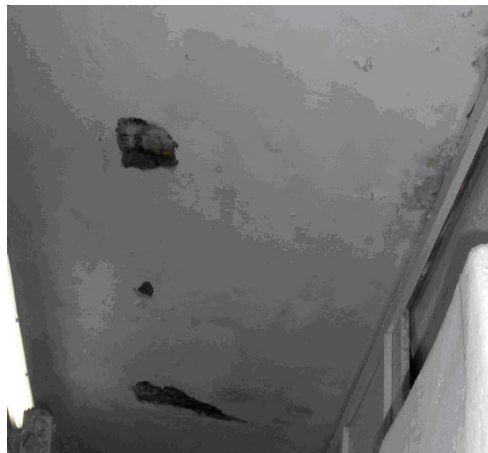
Fig. 4. “In-situ” inspection hole of Klein ceiling beams in the cold store in Warsaw

The strength parameters of A-0 grade steels were adopted for static and strength calculations. The strength parameters of the girder were then selected based on the design tables and the actual degree of corrosion for each structural element. Moreover, the girder slenderness as well as the plastic reserve factor were taken into account in the verification calculations. Moreover, the girder slenderness as well as the plastic reserve factor were taken into account in the verification calculations. The load-bearing capacity of the ceiling beams was determined. Then the load capacity loss was calculated due to the self-weight of the structure elements. The load capacity reserve allowed to determine the permissible characteristic loads due to the load-bearing capacity of the steel ceiling girders.

The Klein ceiling beams proved to be the most decisive factor in the load-bearing capacity. The permissible value of the characteristic operational load for the cooling tower ceiling in Warsaw was  $7.5 \text{ kN/m}^2$ . In the next step the Ultimate Limit State was being checked.

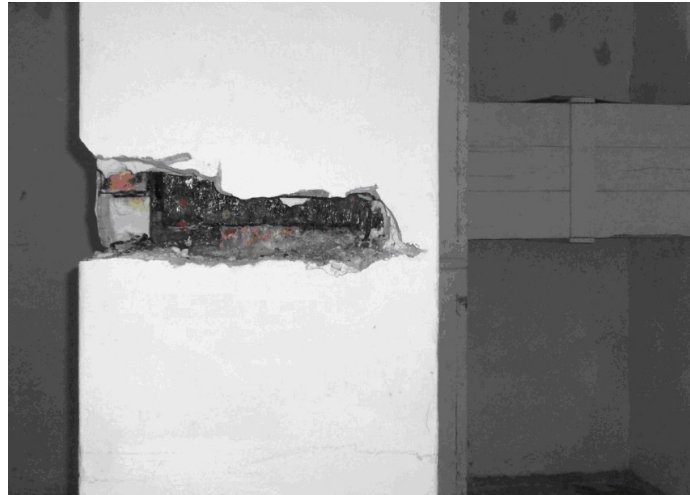
pillars and the permanent load as well as the climatic loads (bags of snow on the roof) were collected. The operational load in the attic as well as the equivalent static load from partition walls on all floors were also taken into account to calculate the remaining loads acting on each column. The columns made of two I260 rolled I-sections with a 12 cm spacing are shown in Fig. 5.

Fig. 5. “In-situ” inspection hole of the steel supporting structure of the column.  
Visible degree of column corrosion

The basement level was assumed to be the most representative for the calculations, in which the columns transfer the loads from all floors of the building. When determining the permanent load, the weight of the ceiling structures on particular floors, the weight of the roof, the weight of the columns, as well as the weight of the binders were taken into account. As in the case of the steel girders, the load capacity of the columns was determined taking into account their slenderness and the buckling coefficient. The calculated load capacity of the columns allowed to determine the permissible value of the design operational load.

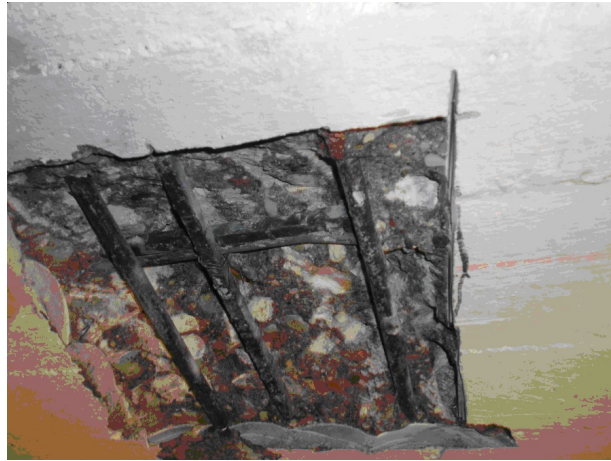
**2.2. Cold storage in Włocławek (Poland).** With regard to the cold store building in Włocławek, the key element for the load-bearing capacity of the structure were the floor slabs, made as monolithic reinforced concrete. The thickness of the reinforced concrete slab was 22 cm and the maximum span width was 6.10 m. During the carrying out of the inspection hole of the ceiling, it was found that the main reinforcement of the ceiling consisted of the alternated bars with a square cross-section of 12 mm and round bars  $\text{Ø}14 \text{ mm}$  at a spacing of 10 cm – Fig. 6.

The main bars with a square cross-section of 12 mm were orthogonally ribbed and made of St50B steel. The yield strength of this steel is 360 MPa. Assembly bars, perpendicular to the main reinforcement, occurred every 30 cm. Their cross-section was square  $12 \times 12 \text{ mm}$ . The lagging of the main steel reinforcement and assembly bars was 20 mm and 40 mm, respectively. On the basis of visual assessment and sclerometer tests, the concrete parameters corresponding to class C25/30 (B25) and parameters of A-II class

Fig. 6. Inspection hole of the ceiling of the cold storage building in Włocławek

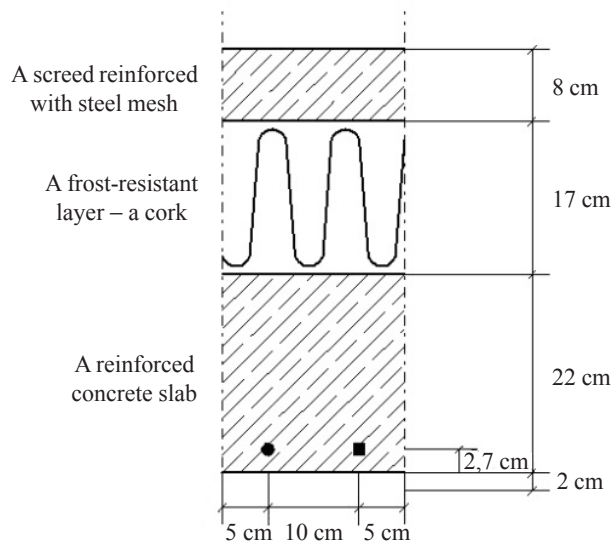
steel [1, 6, 7] were assumed for the calculations. The total ceiling thickness was 47 cm. Analysing the layering system from the top, an 8 cm layer of screed reinforced with steel mesh was found. Then, a 17 cm frost-resistant layer in the form of a cork and a 22 cm reinforced concrete slab were observed. The geometric parameters of the ceiling cross-section, that were adopted for calculations are, shown in Fig. 7.

Fig. 7. The cross-section of the reinforced concrete ceiling section of the cold storage building in Włocławek

On the basis of the strength parameters of concrete and steel, the effective height of the concrete compression zone was determined and the design load-bearing capacity of the ceiling section was calculated. The static scheme of the ceiling section was assumed as a multi-span continuous beam based on binders. As in the case of the cold store ceiling in Warsaw, the ceiling load-bearing capacity was determined in a first place. Both, the actual weight of the structural and non-structural layers of the ceiling were considered. This capacity reserve allowed to determine the permissible value of design operational

loads. After considering the technical condition and ceiling wear, its operational load was specified as 8.8 kN/m<sup>2</sup>.

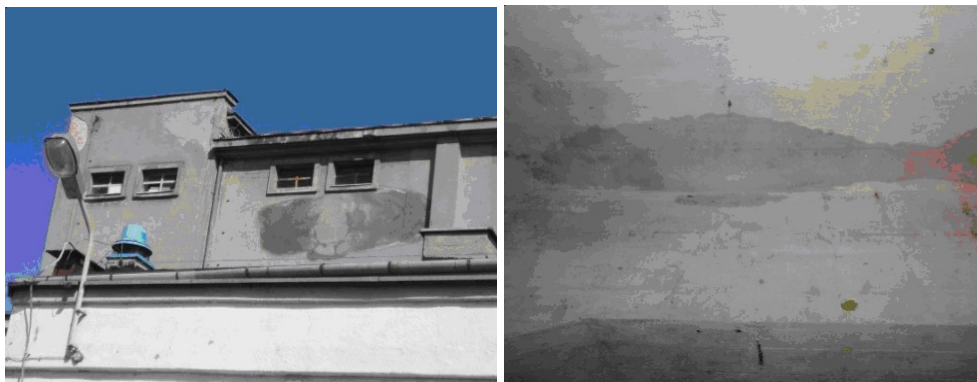
The analysed buildings were built in the same period of time and according to the same regulations and technical standards binding at that time. Despite the very similar dimensions of the cold storage buildings and similar spans of structural elements, they were made of various construction materials. However, the use of various built-in construction materials, in combination with the real estate maintenance process and conditions, caused a different degree of technical wear of these cold storage facilities. The masonry and steel structure built in Warsaw was much more damaged than the reinforced concrete structure of the cold storage in Włocławek. Weather conditions and the environment, including low temperatures combined with the moistness of the structural elements caused significant corrosion of steel elements. The loss of the cross-sectional area of the steel structural elements caused by corrosion amounted to approximately 0.5 mm. It caused the weakening of the cross-sections by 10% (reduction of the strength index). The technical wear in the reinforced concrete structure was much lower. The degree of corrosion of the reinforcement and concrete was much smaller and the determined weakness of the sections of the structural element was 3%. The factor that caused the most technical wear and weakness of the structural elements was moisture. The improperly thermally insulated walls and ceilings of the cold storage chambers were subjected to moisture and the accelerated degradation – Fig. 8.

Fig. 8. The examples of the moisture-caused damages of the cold storage structural elements

Moisture in the structural elements had a particularly destructive effect on the steel elements that were unprotected against corrosion. The actual thickness of the ceiling layers was verified in the performed in-situ inspection holes. This enabled then a precise determination and assessment of the technical condition of each structural element of the ceiling. The renewal of the frost-resistant layers was recommended in both presented cases. The disassembly of the floor layers in cold storage rooms required special attention to the manner of conducting the construction works. The use of a manual and a light equipment was allowed due to the possibility of the disturbance in the behaviour of the ceiling structure.
